Version 1.0      8 May 2026

# **Centering Accessibility in Bus Stop Planning: A Data-Driven Framework**

Jack Nierenberg is the Vice President of Passengers United and a Master of City Planning candidate at the University of Pennsylvania Stuart Weitzman School of Design.

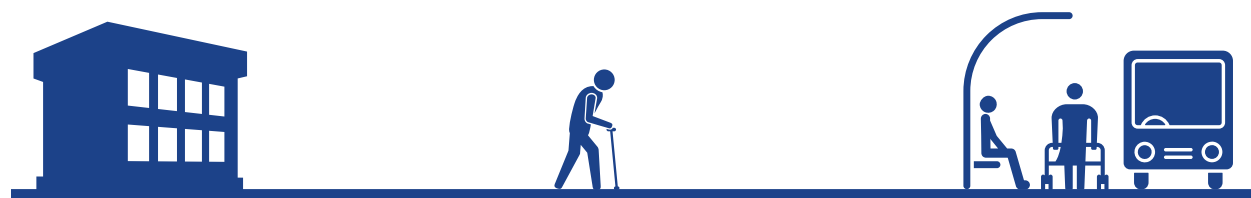
● 3 Pathways: first/last mile, waiting at the stop with ease, and boarding/alighting the bus.

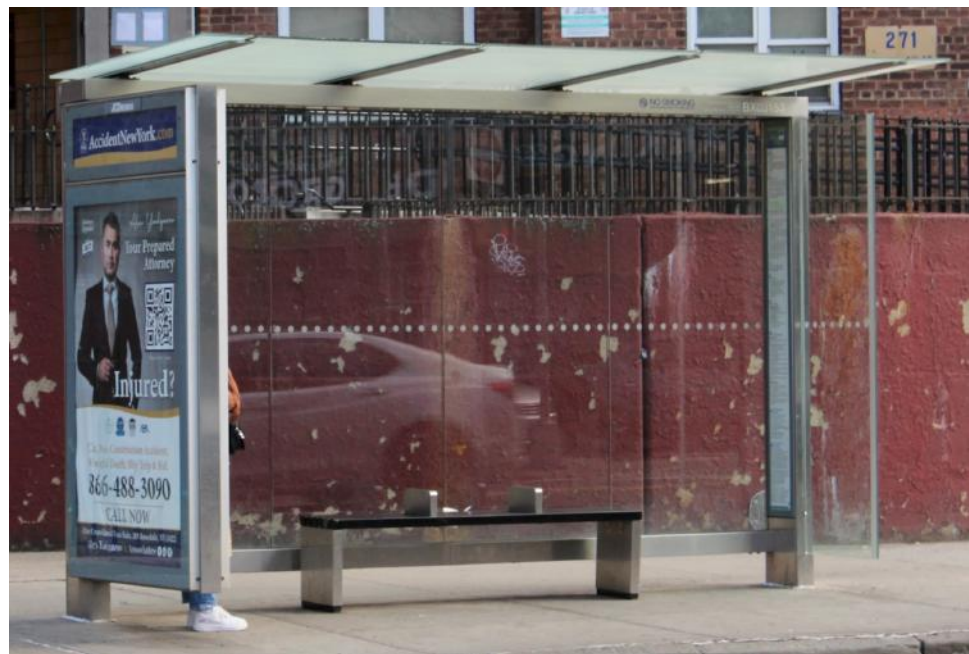
5 Typical bus shelter with seating in New York City.

This factor specifically addresses the presence of a bus shelter, which protects riders from the elements (rain, snow, heat, wind, etc.), and seating for riders to use while they wait for the bus. Seating is particularly important for riders with mobility impairments, who may experience difficulty or discomfort standing for extended periods of time. Leaning benches do not count as benches because they do not allow for people to sit fully.

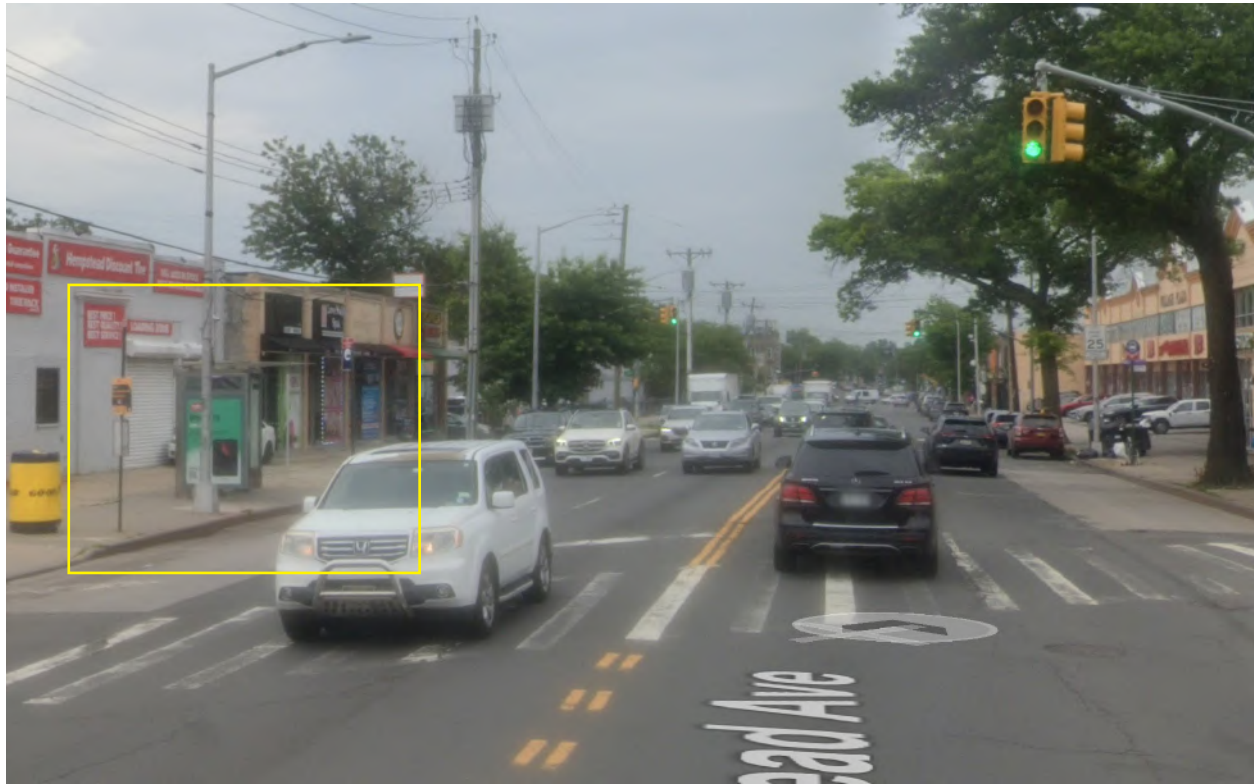
6 Hempstead Avenue and 217th Lane. Source: Google Street View.

Hempstead Avenue is a mixed-use corridor in residential Queens Village, a neighborhood located near the Queens-Nassau border. The former westbound Q110 bus stop at the near side of Hempstead Avenue and 217th Lane (highlighted in Figure 6) was eliminated in the Queens Bus Network Redesign. It was one of the nine areas designated for prioritized stop restoration in Phase 1 of this project for four reasons. First, this stop served an area with a high share of residents with mobility disabilities, according to the American Community Survey (see Phase 1, page 28). Second, it was the only stop in the immediate vicinity that had a bus shelter with seating. Third, it served a laundromat across the street. Fourth, the eastbound stop across the street (now served by the Q82 Rush route) was kept intact. It is also worth noting that many of the residential and commercial properties along Hempstead Avenue have active driveways — a potential risk factor for pedestrians.

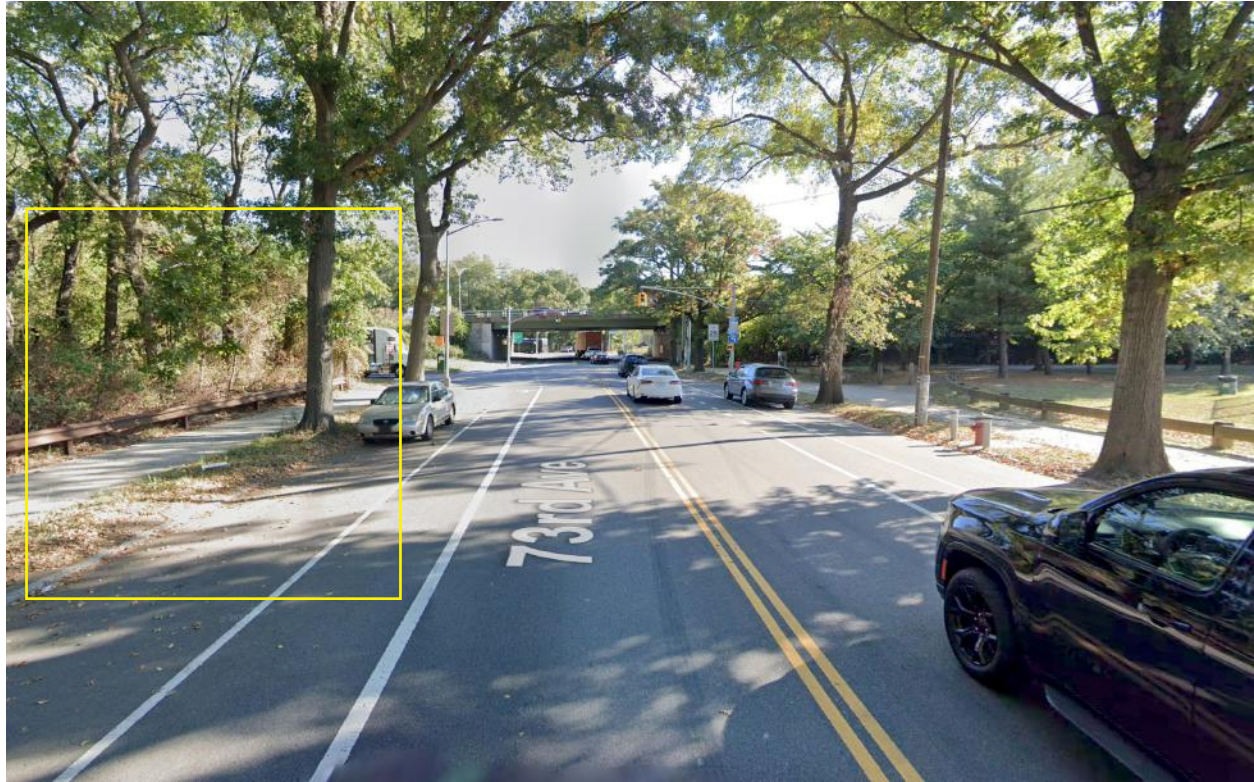
8 Site of new Q88 bus stop at 73rd Av & Clearview Expressway exit ramp. Source: Google Street View.

The Queens Bus Network Redesign did not only involve bus stop consolidation; in fact, some bus stops were added along existing routes. But just how beneficial are these added stops? One example is along 73rd Avenue in Cunningham Park, which separates Fresh Meadows from Oakland Gardens. A westbound stop was added along the Q88 route, which runs along this stretch of 73rd Avenue, just past the Clearview Expressway (I-295) exit ramp. Based on the map alone, it seems that this stop serves to address a gap in stop coverage, expanding access to westbound Q88 service for park users and visitors. However, a site evaluation of the stop using the CBSAI would suggest a different conclusion.

However, there is no crosswalk at all between the westbound stop and the park entrance, and, as a result, no safe pathway exists between the two. This is an example of a “dealbreaker” stop, which is denoted by a negative Pathway Conditions rating. Other favorable conditions are outweighed when riders cannot access the stop (or nearby destinations from the stop) without jeopardizing their safety, or if the stop cannot be accessed at all. In this case, because there is no way to get
